OVERLOOK AT QUALCHAN

ROAD MAINTENANCE STUDY

1/5/18

FLEET ENGINEERING LLC

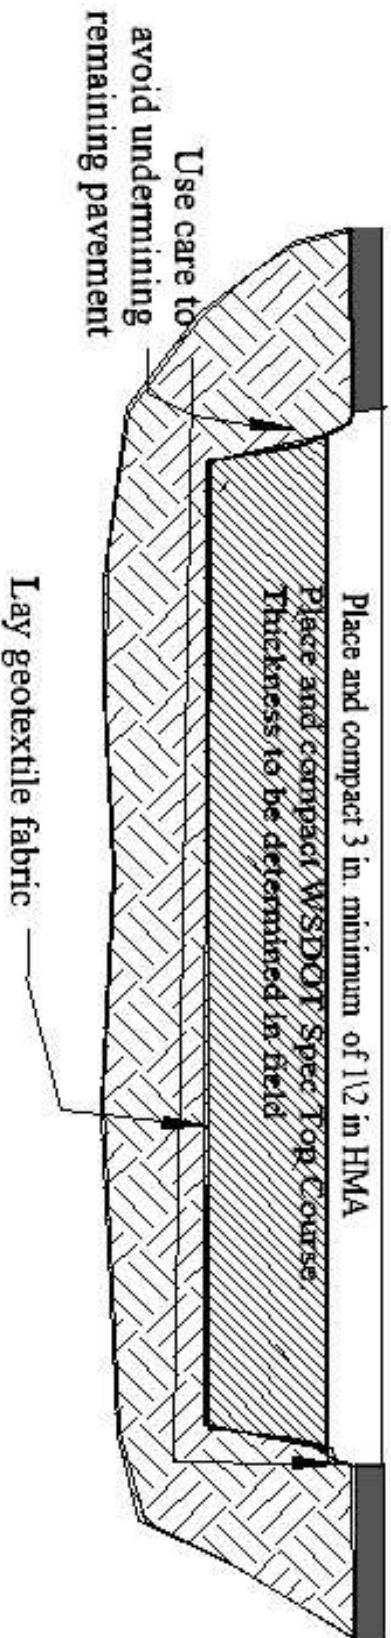
PAVEMENT REPAIR DIAGRAM

There is about 110 SY of alligator cracking; surprisingly little for a road this old, but more importantly, none of it is serious. Sometime in the next 4 to 5 years, it should be repaired. But in the mean time, regular crack sealing and surface treatments will keep it at bay. Right now the road is overdue for crack filling and fog sealing. Do that as soon as possible. See attachment 1 for details on a typical pavement repair.

1. Saw cut pavement along marked lines.
2. Excavate the area to specified depth then level and compact the subgrade.
3. Use care to avoid damaging or undermining remaining pavement.
4. Place geotextile fabric
5. Place and compact approved thickness of WSDOT specification CSTC, or approved equal. Place in 2 lifts if total thickness is more than 4 in.
6. Tack the existing pavement edges.
7. Place and compact 3 in, minimum of WSDOT 1/2 in HMA.
8. Coat the joints with tack material.

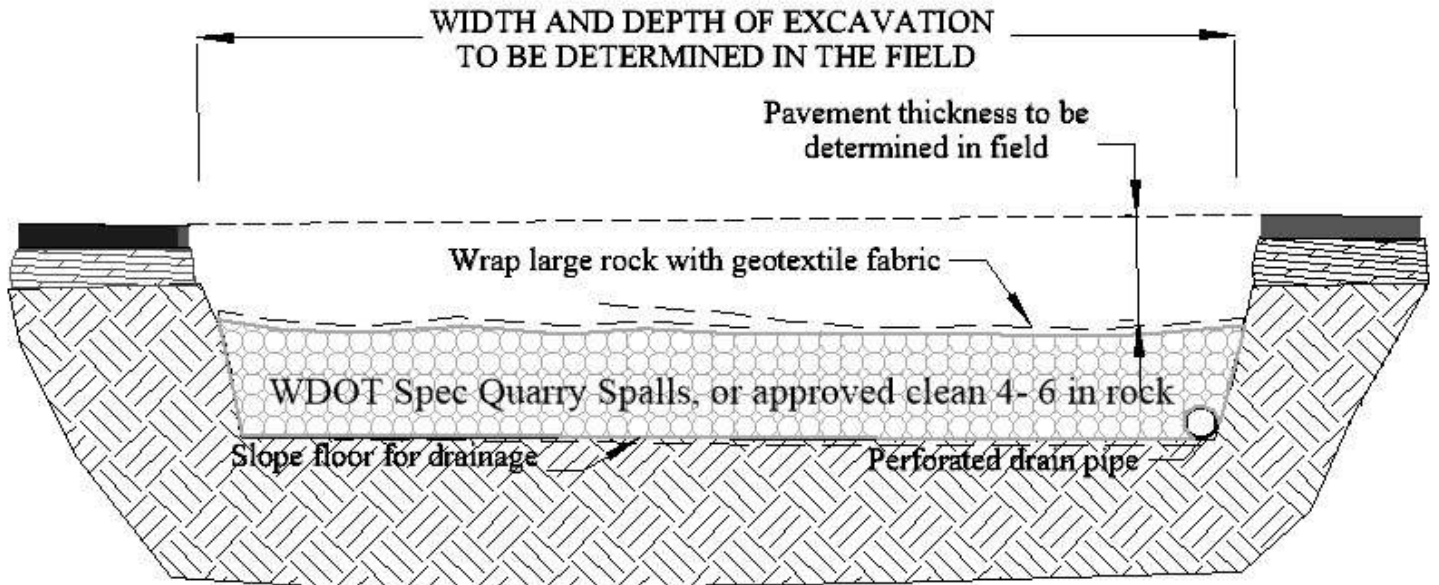
UNSUITABLE SUBGRADE EXCAVATION AND BACKFILL DIAGRAM IN AN EXISTING ROAD

RECOMMENDATIONS FOR UPPER WEST BOLAN: A good share of the road is already in total failure, and there is no preventive maintenance treatment that will restore that. The cause is a clay deposit and an active spring flowing through the area. Attempting to repair the pavement without addressing the water problem would be a futile exercise in throwing good money after bad. Right now, the road is ugly but usable. However, the problem is like a ticking time bomb. It might be useable for some time, but eventually the right combination of winter and spring weather conditions will occur and the road could become nearly impassable.

The usual strategy is to excavate the unsuitable soil approximately 4 ft deep, place a geotextile fabric and then backfill with 4-8 in diameter clean rock. The backfill is left about 12 in below the road surface. Then a new pavement section with layers of crushed rock and asphalt can be installed successfully. Provisions must also be made to collect and dispose of the ground water. It is done by installing a sub drain system to channel the water into an acceptable drainage facility. See Attachment 2 for details of unsuitable soil repair.

The area that is causing the problem is approximately 400 ft by 10 ft. The repair process is referred to as "Sub-Excavation". A large hydraulic excavator is brought on site to remove and dispose of the unsuitable material. The excavated area is lined with a poly-ethylene geotextile fabric and a perforated pipe is installed to keep the water drained out of the area. Then the excavated area is backfilled with 8", or smaller, clean rock. After the sub-excavation is done a new roadway is constructed in that area. The exact quantity of work can only be determined during the repair work. It could be a much greater area, but it is probably less. See attachment 2 for more details.

1. Use care in placing large rock to avoid damaging geotextile.
2. When severe pavement damage has occurred and excavation is required, it is best to place and compact 4" of asphalt (HMA) over 8" of crushed rock.
